# **AAV IRAM TRANSMISSION REVIEW**

## **INTERIM REPORT TFLRF No. 334**

March 1998

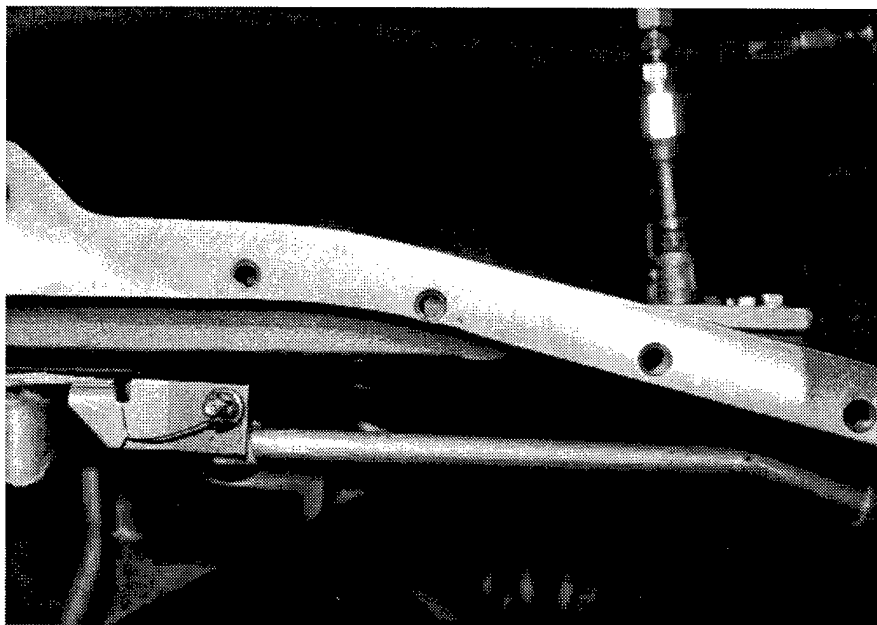
The gasket leakage stems from the insufficient gasket area (Figure 1), housing warpage (Figure 2), and poor quality gasket material. The access plate on the rear of the transmission, a common leakage area, has a cutout that leaves a very thin gasket surface, plus a very sparse bolt pattern in the same area. Attempts to torque the plate bolts to increase the pressure on the gasket tend to buckle the plate corner effectively reducing the pressure on the gasket. Additionally, a matched end plate and speed change housing may have had the bolt pattern shifted during original production such that insufficient gasket sealing surface remains. Gasket leakage also occurs due to warpage of the speed change housings. The warpage stems from the welding procedures used to repair the cracks in the housings (Figure 3).

**Figure 1. Insufficient Gasket Area**

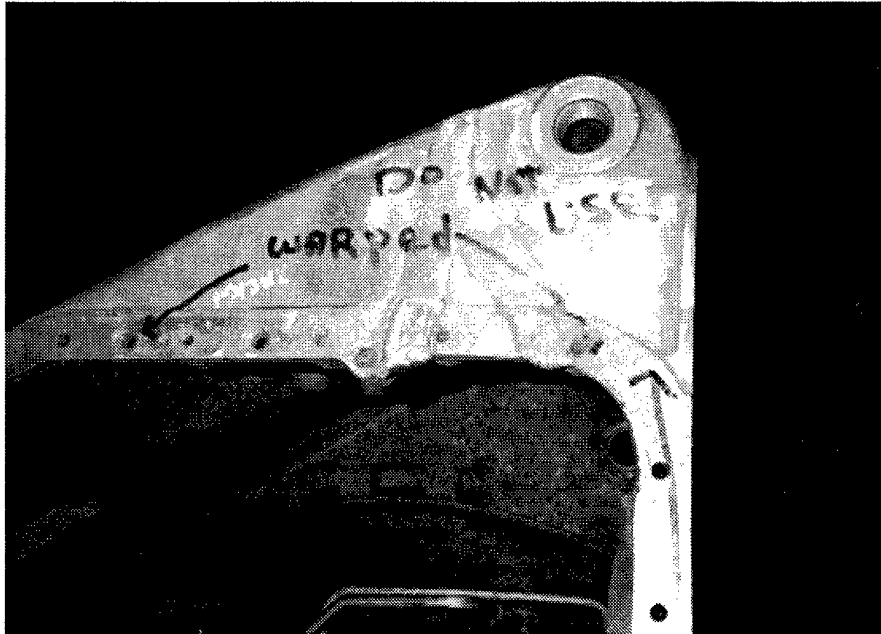
**Figure 2. House Warpage**

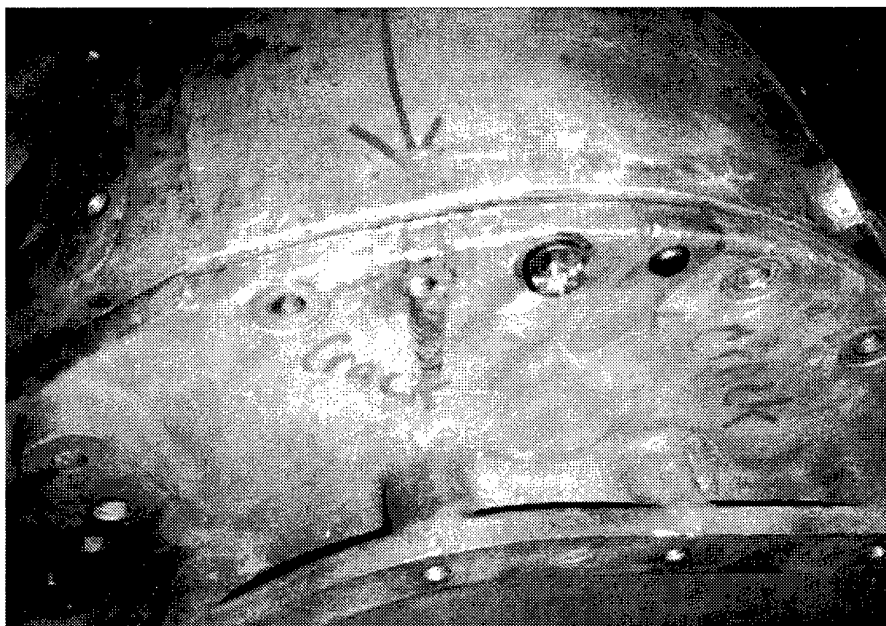
**Figure 3. Crack at Dowel Pin Boss**

Housing cracks appear due to disassembly and handling procedures and incorrect vehicle operation (Figure 3). Each time a transmission is rebuilt increases the likelihood of speed change housing damage. An example is that a crack typically shows up at a location consistent with the lower jackscrew used to separate the end plate from the speed change housing. It was noticed that there was localized yielding of the aluminum housing material at all jackscrew locations. Cracks were evident at the lower speed change housing dowel pin boss (Figure 3). The cracks in the dowel pin boss are typically repaired with Devcon epoxy putty. Another typical speed change housing crack occurs due to failure of the fan drive universal joint. The fan drive universal joint fails, and the flailing drive shaft impacts the speed change housing causing cracks. An ECP was developed to prevent this damage but was never implemented.

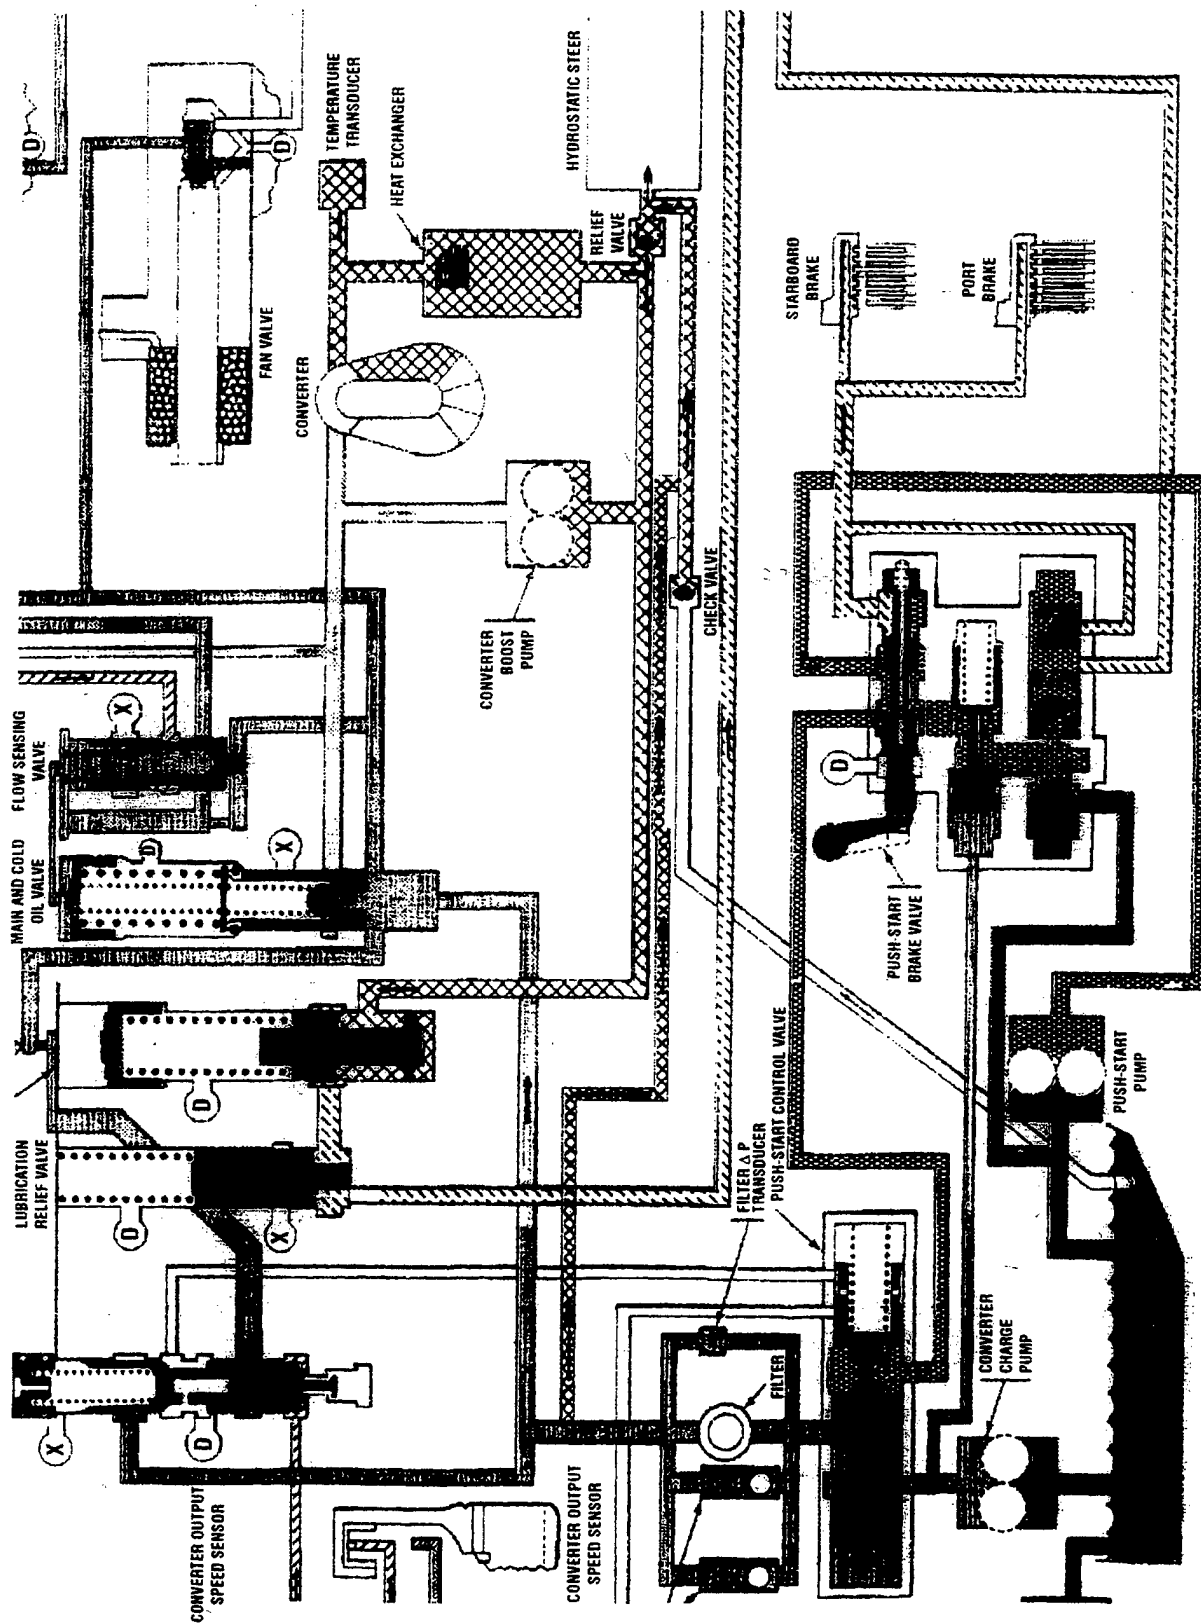
MC3 submitted a suggestion for improving the quality of the oil entering the HSU by modifying the filtration system. The re-plumbing of the oil system would tap into the oil line after the main oil filter (Figure 5). This method would improve the quality of the oil entering the torque converter pump, bypassing other debris-generating components. If approved, modification needs to be evaluated to determine if the oil flow pattern change and pressures effect the operational performance, i.e., AVTB.

Figure 5. Barstow Recommended Oil Flow Modification

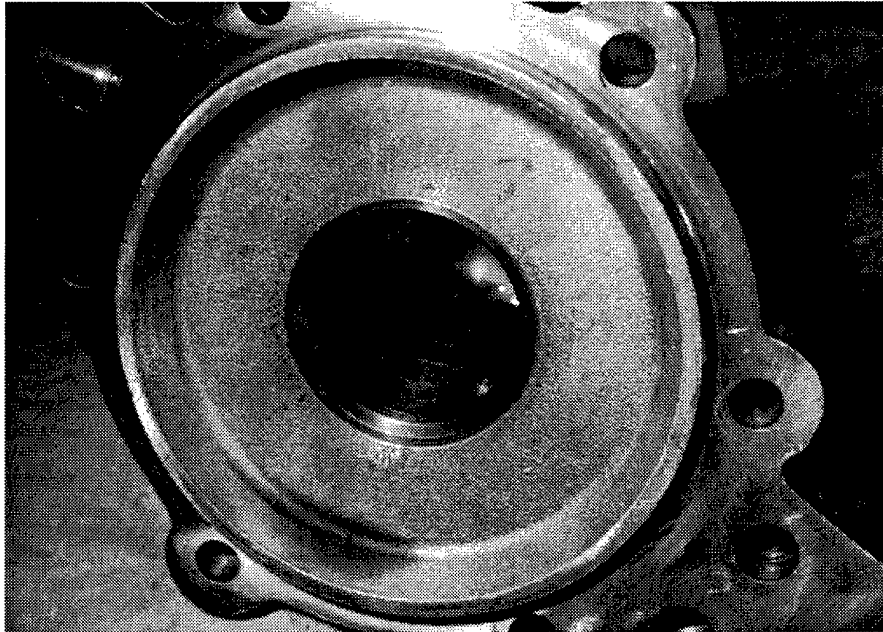
**Figure 6. Inside Cover Using Aceomatic Seal Rings**

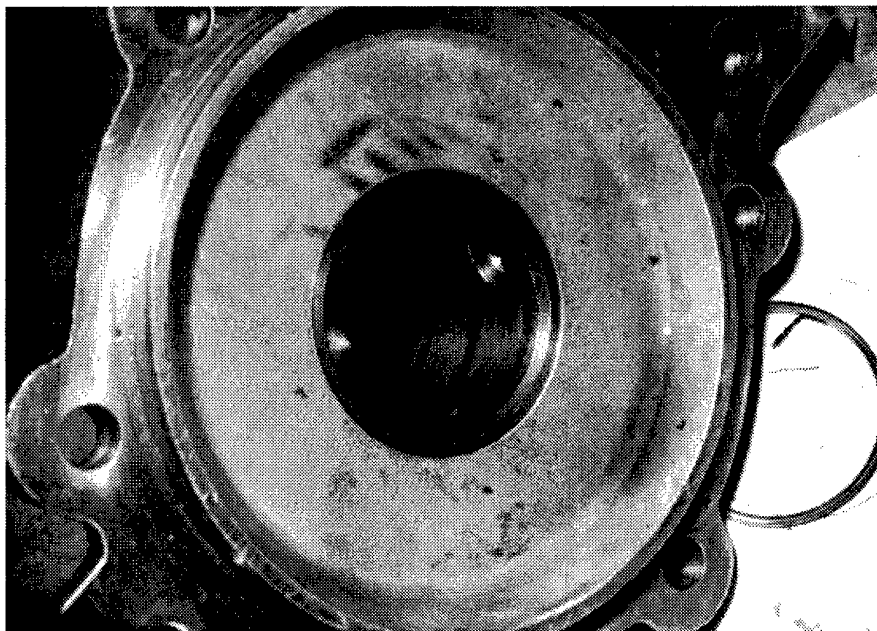
**Figure 7. Inside Cover Using Twin Disc Seal Rings**

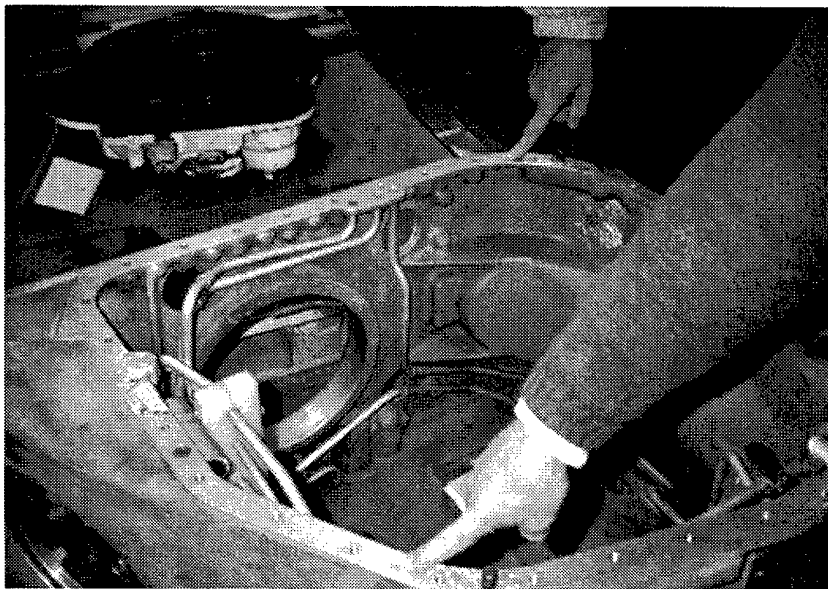
Speed change housing problems included housing cracks from jackscrews (Figure 8), fan drive universal joint failures, tubing swages, mismatched nylon tube locating blocks, bearing bore damage from spun bearings, and housing warpage from crack welding procedures.

**Figure 8. Flange Deformation Due to Jackscrews**

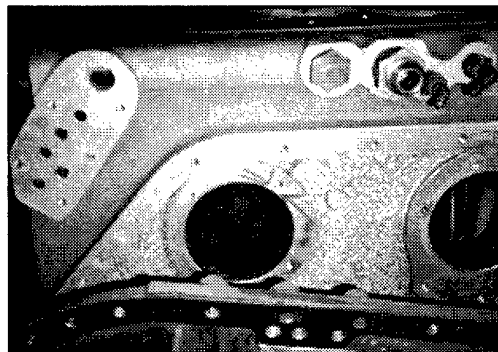
Inspection of several speed change housings indicated the bearings for the clutch shafts have been spinning within the bearing bores. The bearing press-fit is obtained by heating the aluminum housings to 300°F and cooling the steel bearing to -38°F. AERA, Inc. analysis suggests when the housing and bearings reach room temperature; the stress in the housing bores exceeds the yield strength of the material, relieving some of the press-fit (Figure 9). When the transmission reaches its operating temperature in the 190-210°F range, the greater thermal expansion of the housing relieves the press-fit and allows the bearings to spin. Housing bearing bores, which reveal extensive damage from spun bearings, are sleeved with a material of higher yield strength.

**Figure 9. Bearing Bore Damage**

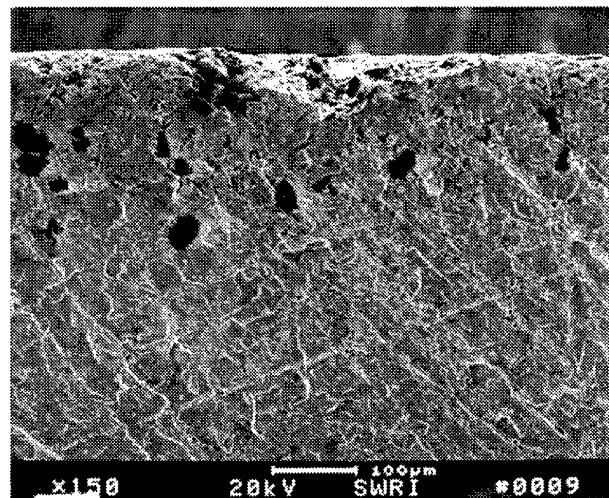
Following the hardness tests, the seal rings were examined under a low power stereomicroscope and in a Scanning Electron Microscope (SEM). The new Twin Disc seal ring exhibited chipping along the machined edges (Figure 10). A large radial crack was also present in the new ring (Figure 11). The broken Twin Disc seal rings (Figure 12), removed from the transmissions at MCAGCC exhibited more extensive chipping than the new seal ring.

**Figure 10. New Twin Disc Seal Ring**

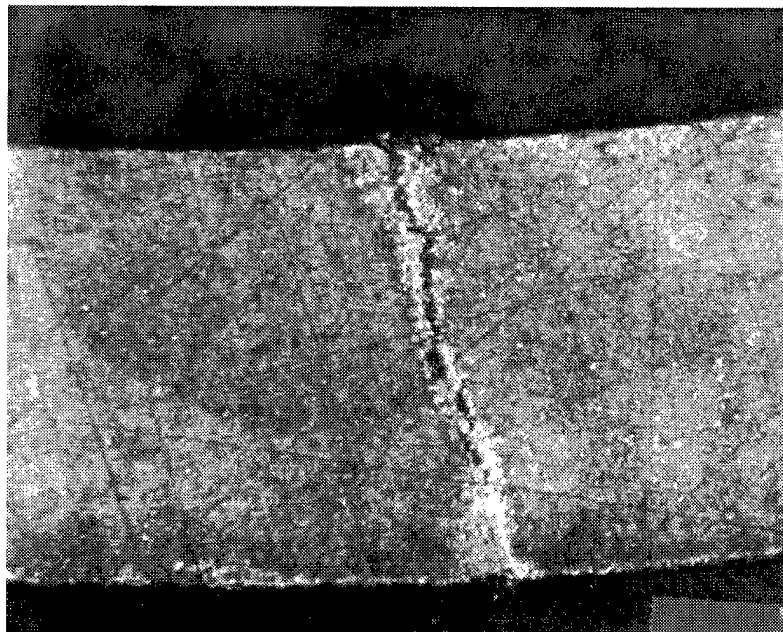
**Figure 11. Cracked New Twin Disc Seal Ring**

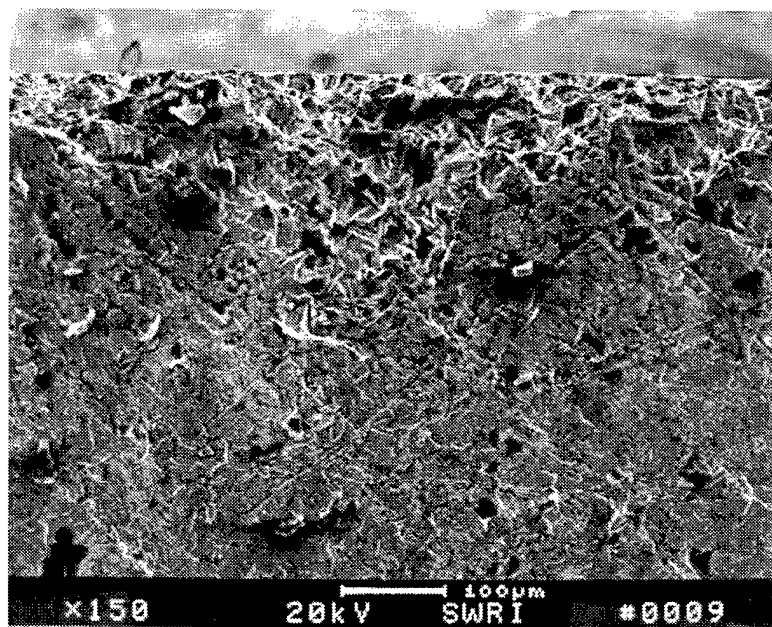
**Figure 12. Used Twin Disc Seal Ring**

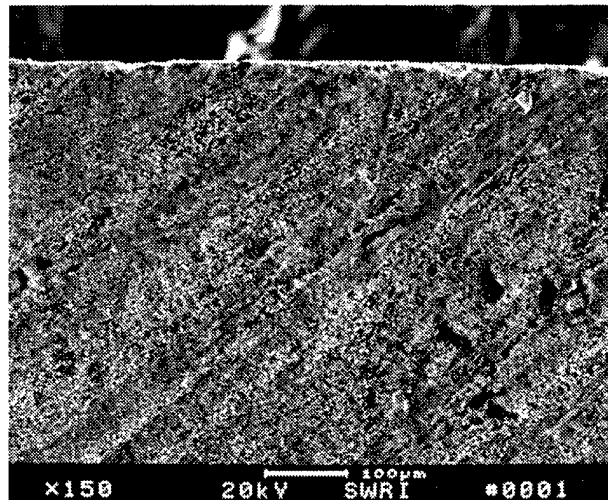
The appearance of the new Aceomatic seal ring was very different from that of the new Twin Disc seal ring. Very smooth edges, as shown in Figure 13, were evident around the entire ring, and no evidence of chipping or cracking was observed. The used Aceomatic seal rings that were delivered to SwRI from Barstow also exhibited smooth edges that were free of chipping and cracking, Figure 14.

**Figure 13. New Aceomatic Seal Ring**

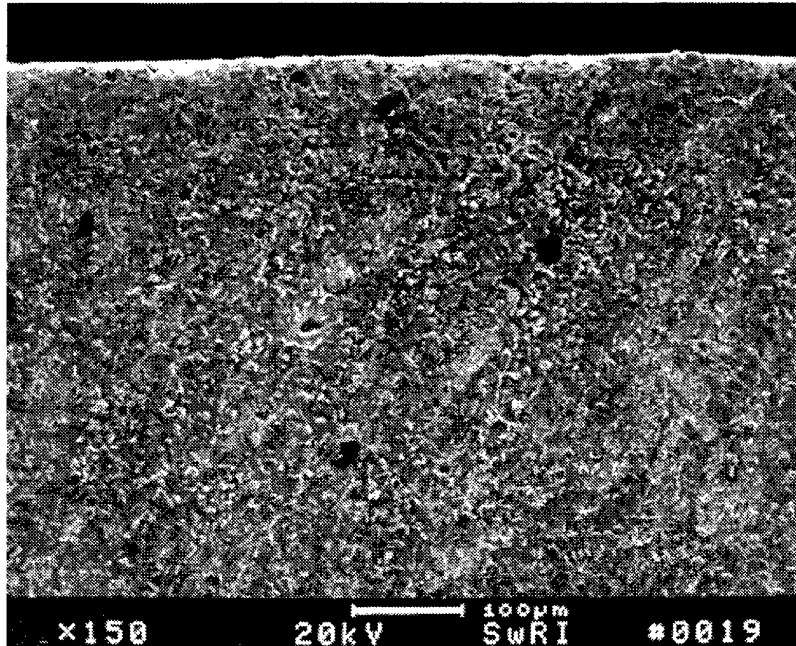
**Figure 14. Used Aceomatic Seal Ring**

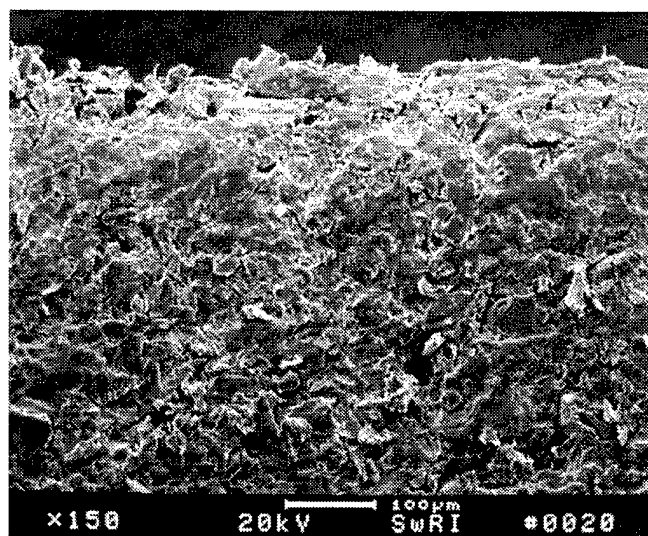
New and used, bronze impregnated, Teflon seal rings were also examined. As expected, their appearance was very different from either of the cast iron seal rings (Figures 15 and 16). However, due to the very different nature of the material of the rings, it is impossible to draw any conclusions about Teflon relative to cast iron seal rings from these micrographs.

**Figure 15. New Teflon Seal Ring**

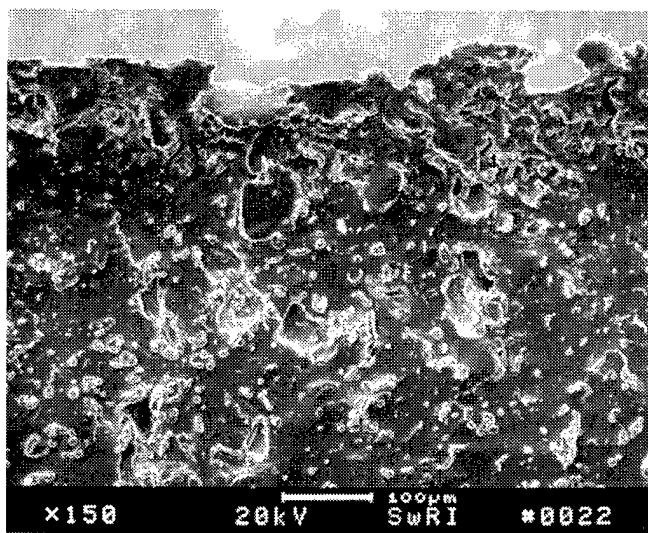
**Figure 16. Used Teflon Seal Ring**

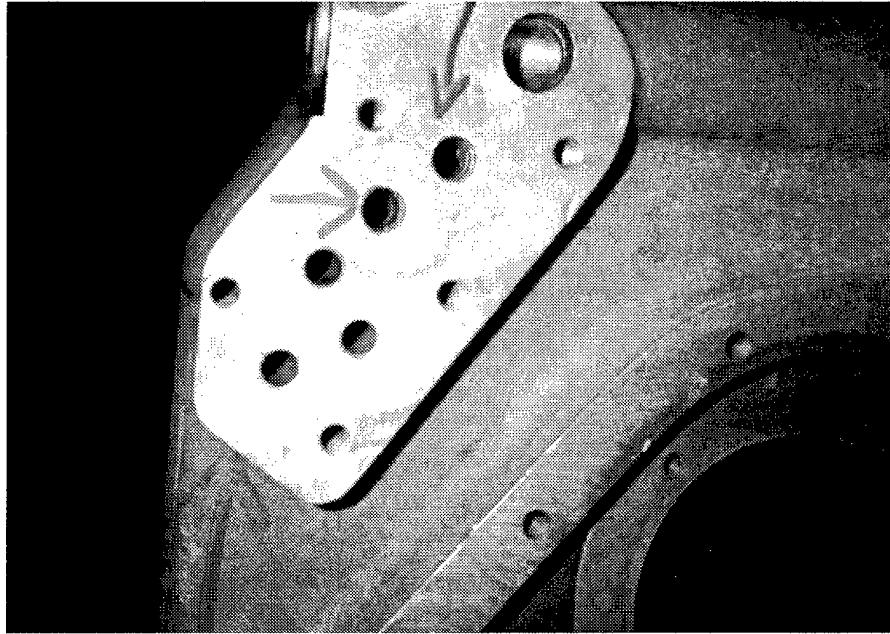
The problem is once the tubes are swaged into their respective holes (Figure 17); vibration of the material loosens the fit. In addition, if the tube swaging process is not performed correctly, the tubing wall thickness becomes very thin, cracking as a result of fatigue. Both of these problems result in the loss of oil pressure.

**Figure 17. Tube Swage Problem Areas**

The proposed method for the tube swaging is to set a limit on the hole diameters, then swage the tube until the ID of the tube is within a prescribed limit. The procedure will result in a 5% to 15% swage of the tube. The advantages of this method are that the number of measurements is reduced and no calculations are required. It will also be easy to determine in a post inspection if the tubes were properly swaged simply by measuring the ID of the installed tubes. The ability to check the degree of swage of an installed tube will be very helpful toward eliminating the improperly installed swage tubes. Although this procedure should aid in reducing the number of tubing swage problems, it is felt that this problem needs additional investigation to produce a better solution.
